～ ヒーロー ～

令和 7 年 1 月 運航技術委員会

CALLBACK

Issue 539

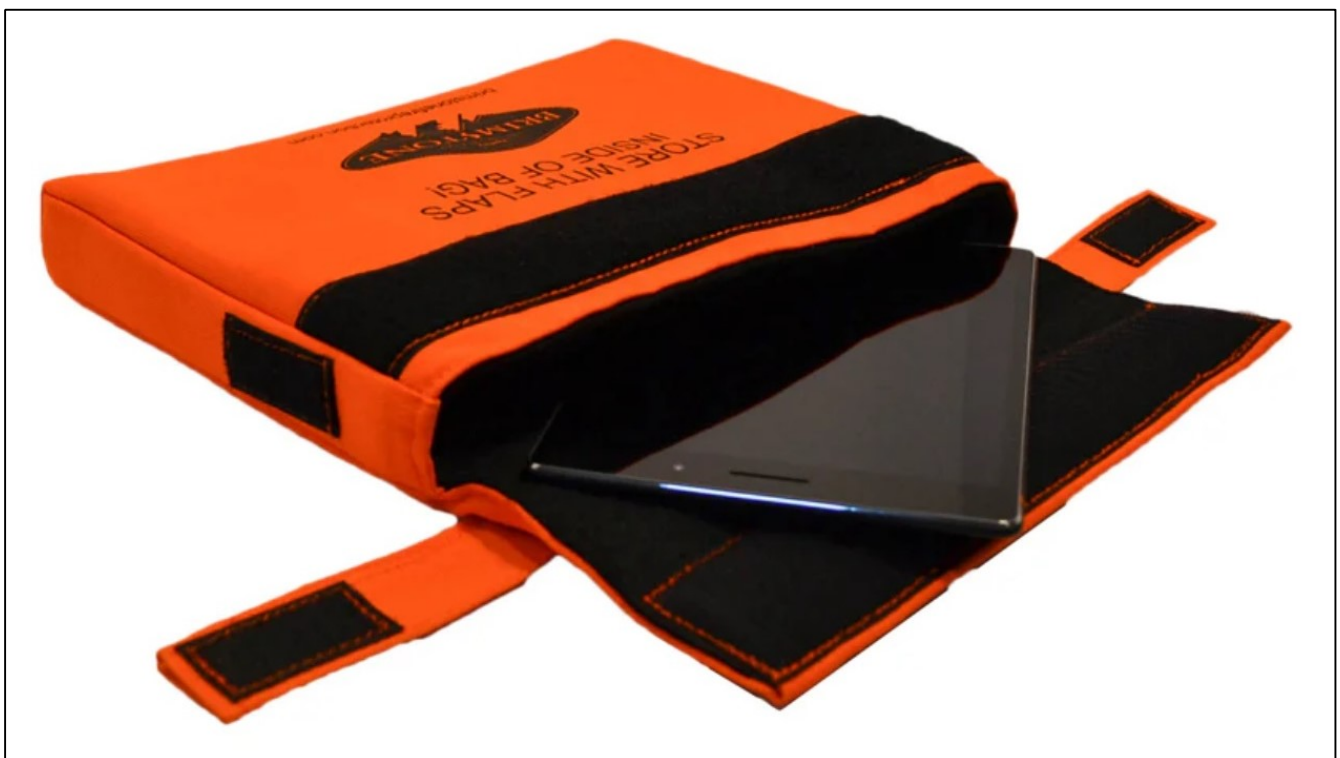
■ 着陸に向けてキャビンを準備していると...乗客の女性が、助けを求めていました。彼女はバッグの中を探ってみて、外部充電バッテリーが何かおかしいことになっていることに気づきました。シューという音を立てていて、そこから煙が出ているように見えました。私は防火バッグ* を取りに走り、機内乗務員 A に水の入ったボトルを持ってついてくるように頼みました。彼はそれを 1 つしか持っていなかったのですが、私たちは席に行き、バッテリーを水と一緒に防火バッグに入れました。それから、もっと水を入れるため後部キャビンに行きました。機内乗務員 B は、水をバッグに入れるのを手伝ってくれました。それから、防火バッグを閉じて、カートに入れました。機内乗務員 C は、フライトの残りの時間、防火バッグをチェックし続けました。私たちは着陸し、消防署が飛行機から防火バッグを降ろしてから降機しました。

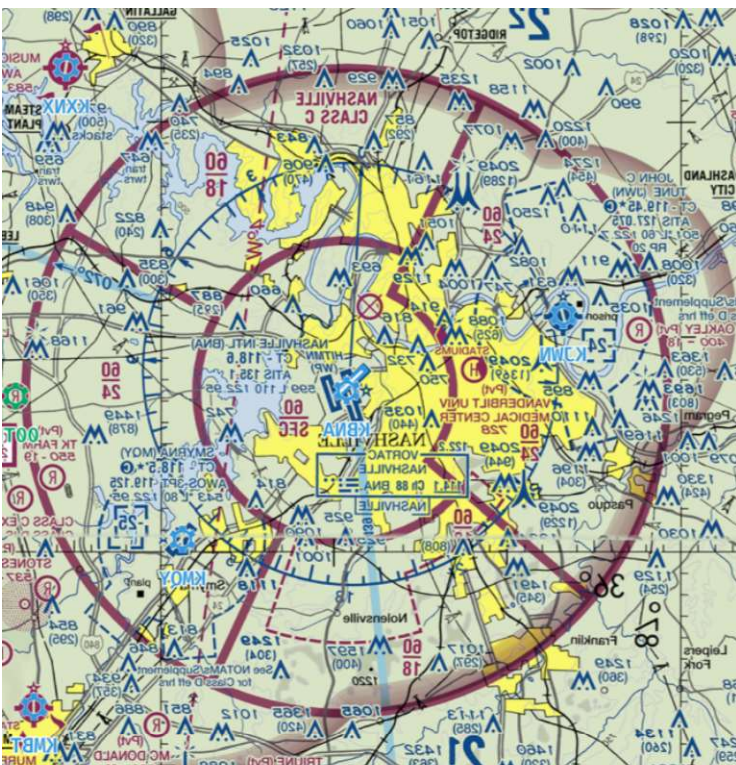
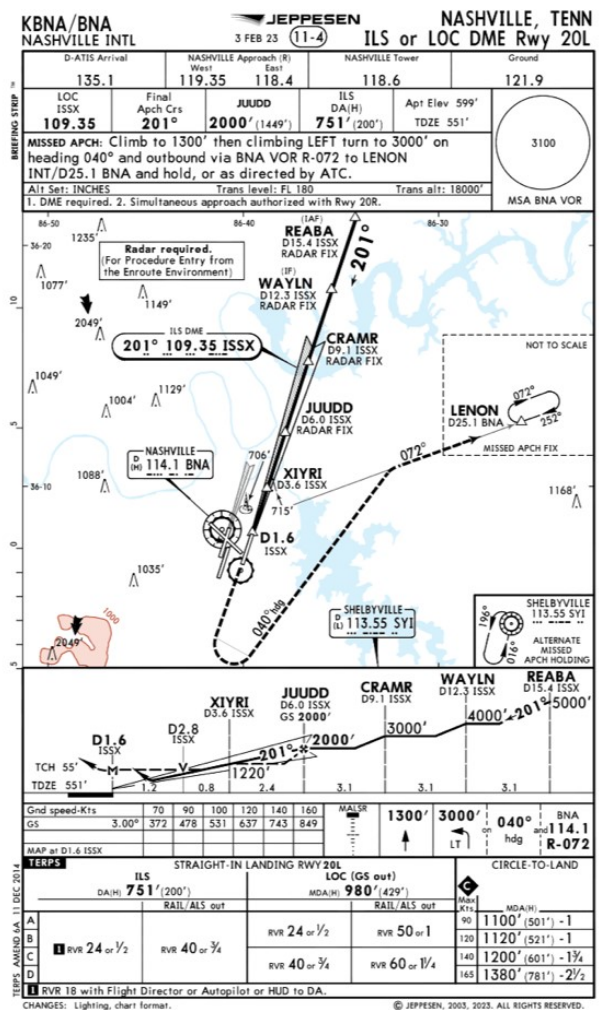
■ 事前コンタクトの無い、ADS-B ではない、1200VFR コード発出している[航空機]が 3,500 フィートでクラス C 空域を侵入しているのが目撃された。その航空機は滑走路 20L へのファイナルアプローチコースに向かって進んだが、そこでは計 6 機の航空機が順次ファイナルに進入していた。当該機は 3,500 フィートを維持しているように見えたので、私は 12 マイルファイナルに向かう VFR トラフィックの下をくぐるため、KBNA 進入中の全機を 2,500 フィートまでに降下させた。航空機 X は、その VFR トラフィックが北西に向かってオーバーフライトし、降下を開始したとき、12 マイルファイナル(WAYLN 付近)にいた。私は周辺機に連絡したが、航空機 X は当該機を視認していた。その後、私は先行していた Y 機

にトラフィック情報を送信し、速やかに2,500フィートまで降下するよう伝えた。その時、当該VFR機のレーダー位置が急速に降下し始め、滑走路20Lへのファイナル方向に旋回し、Y機に向かった。私はトラフィックアラート発出してY機に降下を中止し直ちにHeading 110°へ旋回するよう指示した。私はトラフィックアラートを発出することと、10秒以内で起こる正面衝突を回避することがより重要だと感じたので、彼らのアプローチクリアランスをキャンセルしなかった。その後、私はY機に先行するトラフィック(Z機)に、VFRトラフィックを避けるために旋回し、降下を停止するよう伝え、優先順位を維持させた。RAも死者も報告されなかった。

クラスC空域を広げて監視していて、クラスCルールに違反しADS-B装備していない機を発見した。当該機はクラスCエリア内のルールに違反していたが、クラスCの外でニアミスが発生した。
