Issue 535

August 2024

航空安全情報自発報告制度は、わが国では(公財)航空輸送技術研究センターが VOICES を運営していますが、航空大国の米国では NASA が ASRS を運営し、毎月 CALLBACK を発行しています。この E-Journal は JAPA の運航技術委員会が注釈や補足説明を付加して CALLBACK の邦訳を紹介するものです。

～ 航空における生理的要因 ～

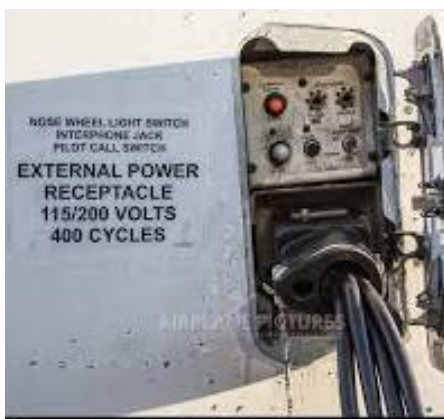
胴体前方右側面 ↑→

■ 進入降下中 ZZZZZ への直行が許可され、11,000 フィートでそこを横切った後、ZZZ [空港] を出発した頃から気になっていた高域ノイズに見舞われた。高域ノイズが気になっていたうえ、通過高度制限のクリアランスの発出が遅かったため、私たちは少し高めにフィックスを通過してしまった。翌日、整備部門に連絡してノイズの原因を調べてもらった。B737 MAX の地上作業員用のヘッドホン・プラグに安全上の問題があるようだった。外部ジャックの位置が高いため、一部の地上作業員はノーズギアのアクセスを使っている。プラグの根元付近を掴んでコードを引き抜くのではなく、数フィート離れたところからコードを引っ張るため、プラグの先端がアクセスの中で折れてしまう。これにより雑音源が蓄積され、最終的には高音になる。このため、乗務員はノイズの大きさに気を取られ、乗務員や管制官との意思疎通が困難になる。この航空機の不具合は、高域音のために生理的な注意散漫を引き起こした。プラグの取り外し方法と安全上の問題の可能性について、地上作業員へ情報提供をしてもらいたい。

737 MAX では、地上作業員が操縦室と連絡をとるためのインターフォンのプラグ差込口が機首側面とノーズギアの二カ所にあるようである。原英文では明確には分らないが、胴体側面にある External Power Receptacle 内のインターフォンジャック位置がやや高いので、代替として Nose Gear に付属しているジャックを使用する地上作業員がいて、プラグを外す時に数フィート離れたところからケーブルを引っ張って取り外すので、プラグの先端がアクセス内に残ってしまい、それがオーディオシステムに高音のノイズを発生させ、ATC との通話に障害を及ぼしていたものと推測される。(下図は 737 MAX とは限らない)

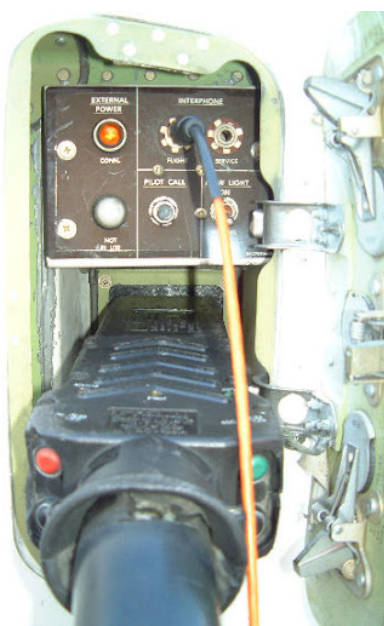
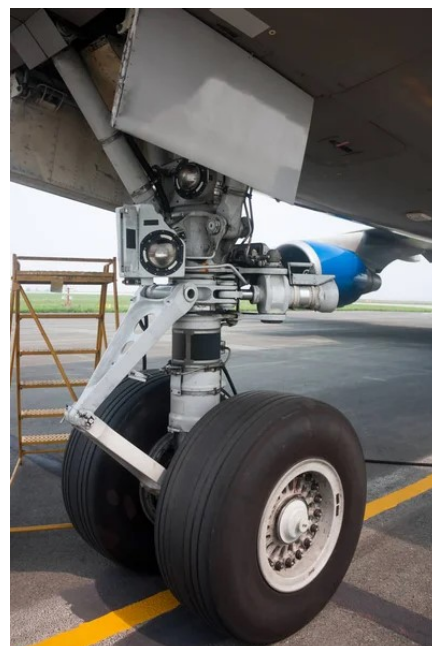
Nose Gear のどこかにインターフォンのジャックがあるのか？ ↑
