Issue 532

May 2024

～ 整備作業の重大性 ～

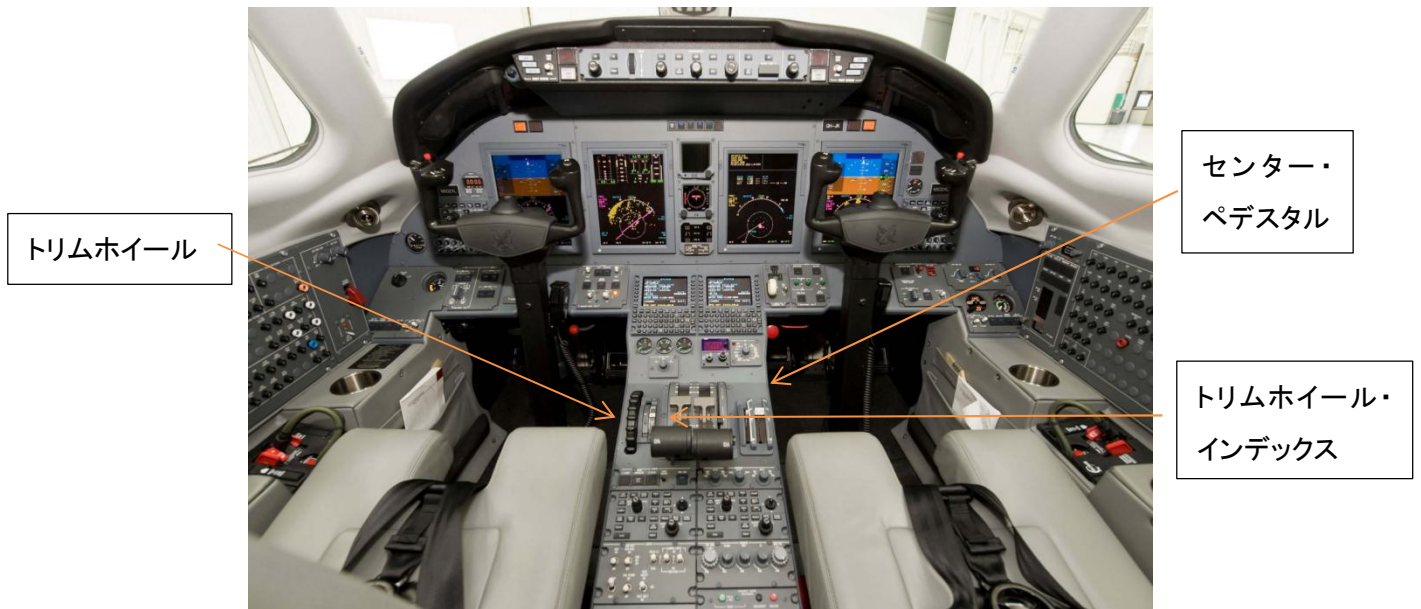
Citation 560XL の操縦室 (Textron Aviation)

■ サイテーション 560XL が定期整備のためにX社にやってきた。私が担当したのは検査書類1であった。この点検では、腐食検査のためにノーズ・ランディング・ギア・アクチュエーター・パネルを取り外す必要があった。パネルを取り外そうとしたところ、いくつかのネジ山が破損しているのを見つけた。さらに調査を進めた結果、36本のネジが長すぎる状態で取り付けられており、与圧区域内の袋ナット(Dome nut*)を破損させていることが判明した。袋ナットにアクセスするためには、操縦室のセンター・ペダスタルを取り外す必要があった。ここにはエルロンのトリムホイールが装着されていた。取り外す前に、トリムはゼロ調整され、コネクティングロッドにはその旨のマークが付けられた。修理の完了には2週間を要した。作業の完了に際しエルロントリムタブがもとのゼロであることは確認できたが、コントロール・ホイールに繋がっているロッドに届かなくなっていた。私は、この作業には携わっていない別の整備士にロッドを調整するのに手伝いを依頼した。彼はロッド両端が互いに届くようにしてくれ、あとの作業を私に任せた。このとき、マークされたインデックスラインはフライトデッキで一致していたため(訳者注:トリムホイールのインデックスがゼロであったためと思われる)、私は実際のトリムタブがゼロ位置でないことに気づけなかった。私はセンター・ペダスタルの取り付け作業とRTS(Return to Service, 整備確認行為)の書類作成を進めた。運航会社のY社は回航のために機体を引き取ったが、クルーは過度のエルロントリムが必要であることを発見し、FBO**に戻ってきた。翌日、私は調査のために呼び出され、トリム位置指示がトリムタブの実際の位置と一致していないことを知った。私は必要なリギング(訳者注:コネクティングロッドの調整)を行い、再び整備確認行為をした。今日現在、当該機はテスト飛行を終え、今般の問題は解決している。
