Issue 537

October 2024

～CPDLC に関わる問題～

Controller Pilot Data Link Communications (CPDLC) は、データリンクを使用してパイロットと管制官がショートメッセージ(クリアランスなど)を交換する通信手段です。米国内では比較的新しい技術であり、急速に進歩し受け入れられてきましたが、一方で進歩の過程における問題もみられます。

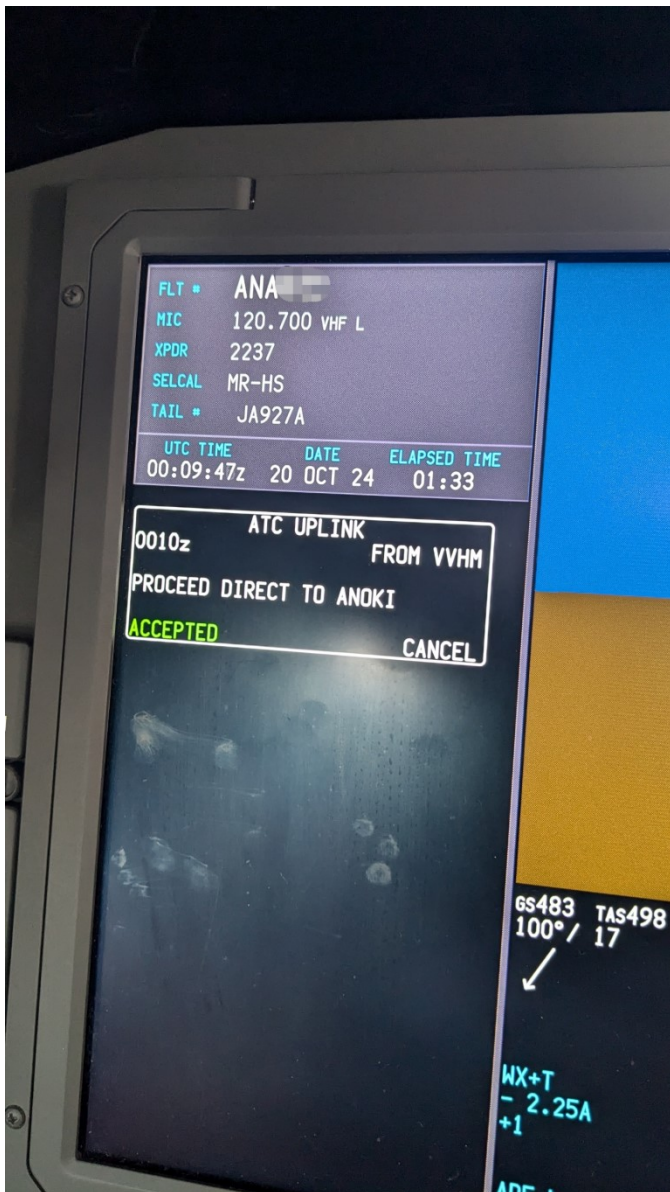
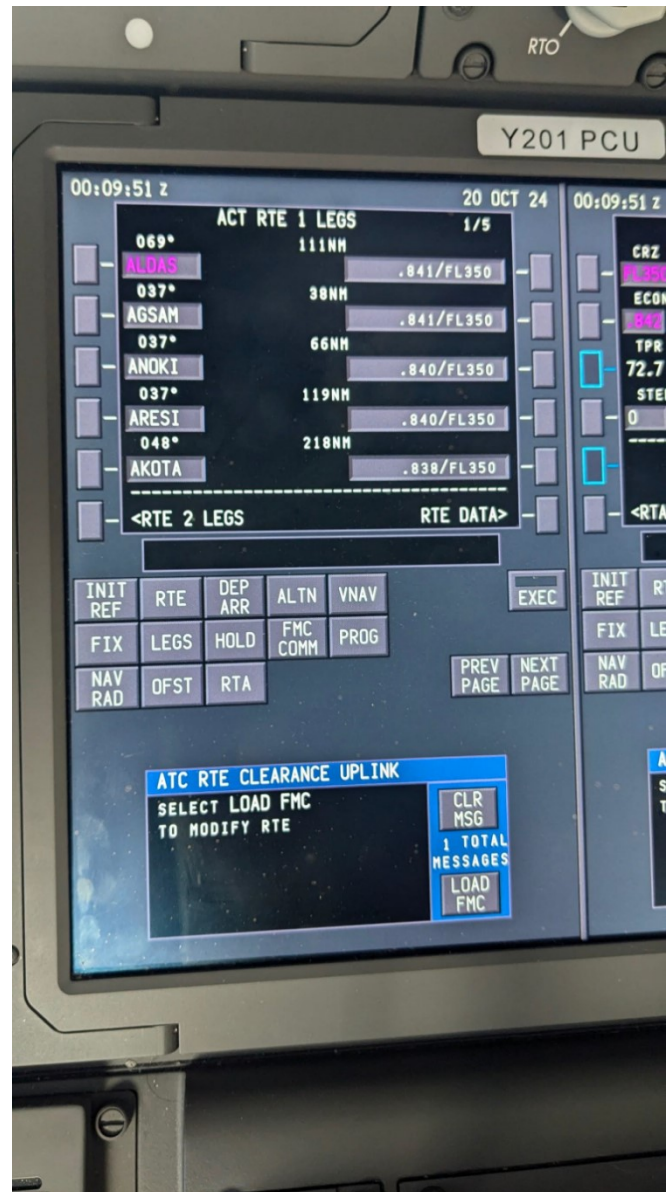
Request Direct ANOKI、と送りましたところ、以下の返事が来ました。

CDU の下にはこのような表示が出て、ここに「LOAD FMC」ボタンがあります。

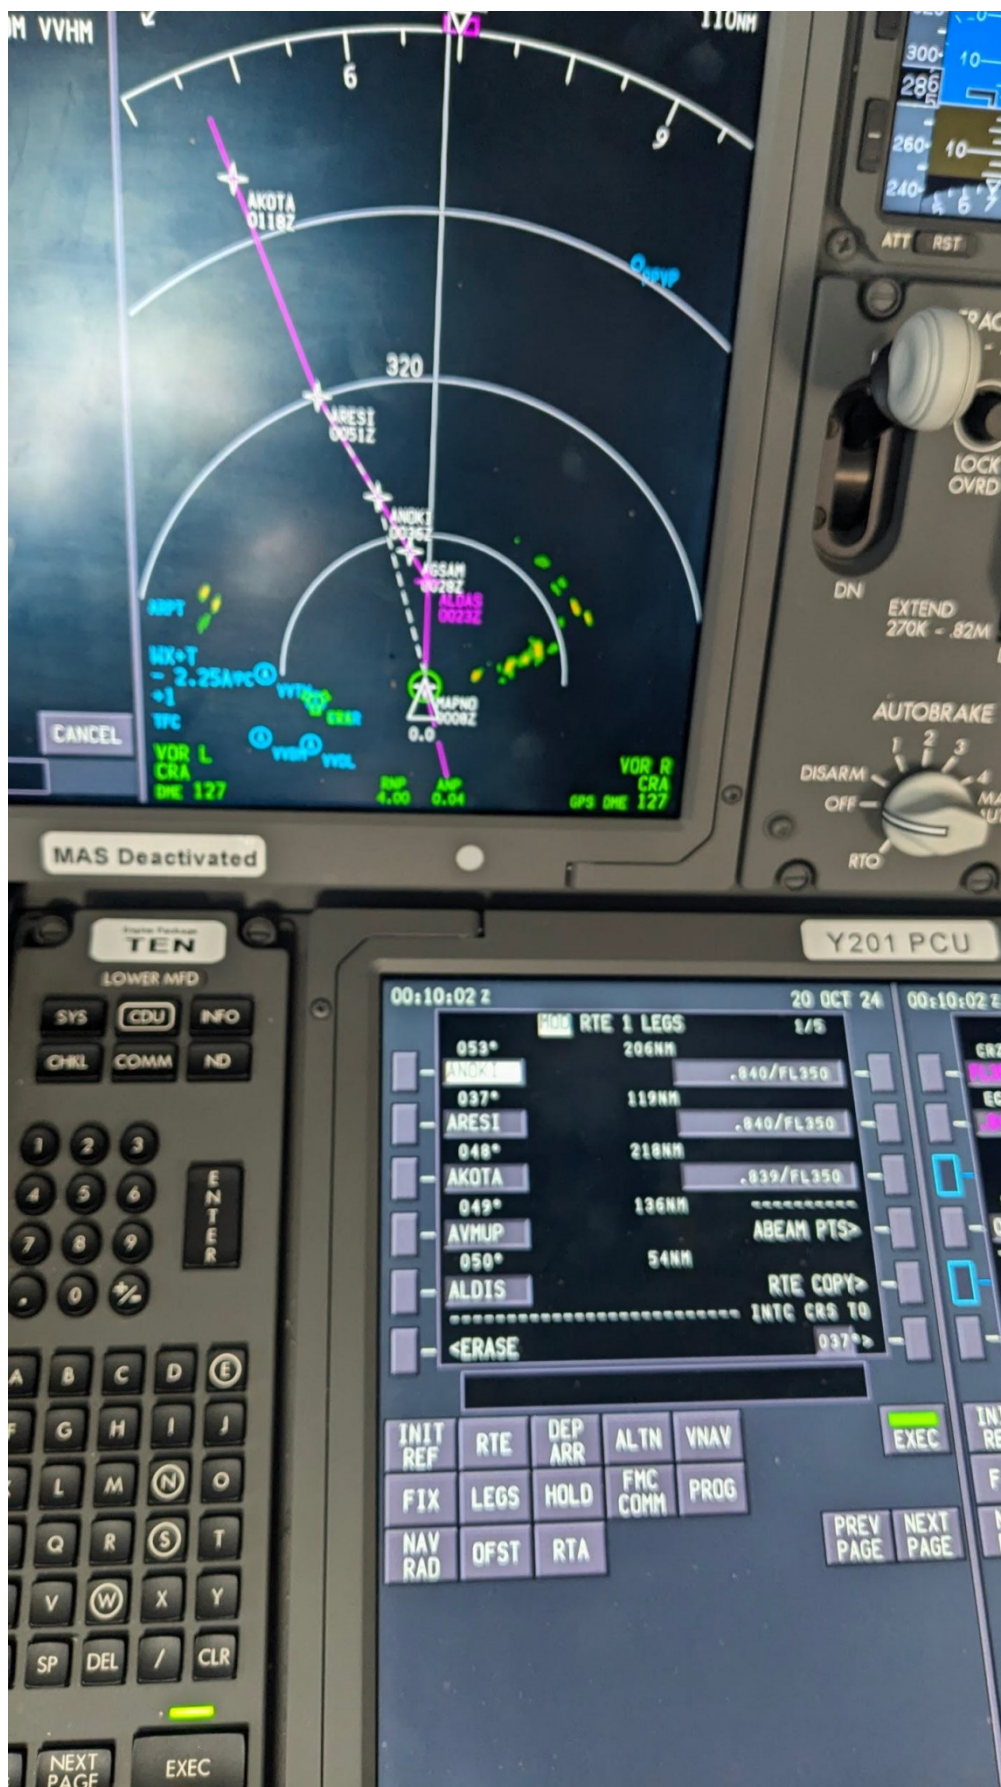
ここで“LOAD FMC”を押すと、ルート変更がFMSに取り込まれ、Stand by EXECの状態になります。
